Steam turbine seal rub. History Case

Abstract: This history case describes how vibration data provided by an advanced online analysis system helped identify the severity of vibrations experienced by a ship's propulsion steam turbine. In their machine plant they have a very advanced monitoring, but as far as vibrations are concerned, they only have an alarm system for vibration amplitude.

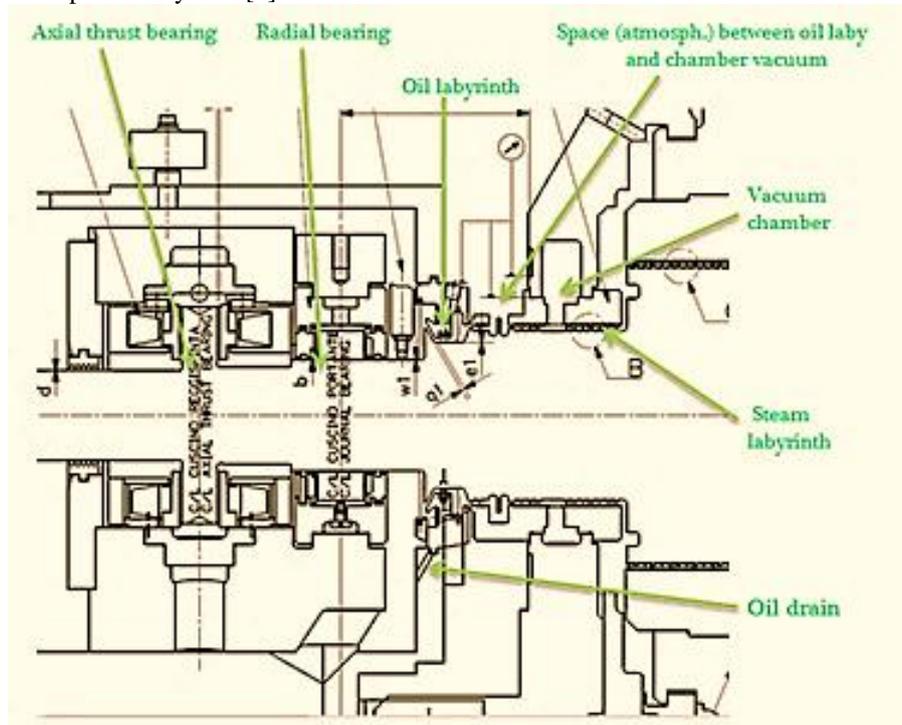
Figure 1. Turbine cross-section drawing.

The drawing in Figure 1 shows a cross-section of the part where the anomaly occurred. The lubrication oil of the bearings is contained by the labyrinth of oil, which sprouted beyond the closing joints of that

labyrinth. Normally, this liquid oil flows into the drain indicated in Figure 1, and any other excess oil, already evaporated by the high temperature, is evacuated from the space between the oil and the labyrinth by the vacuum chamber separation system.[1]

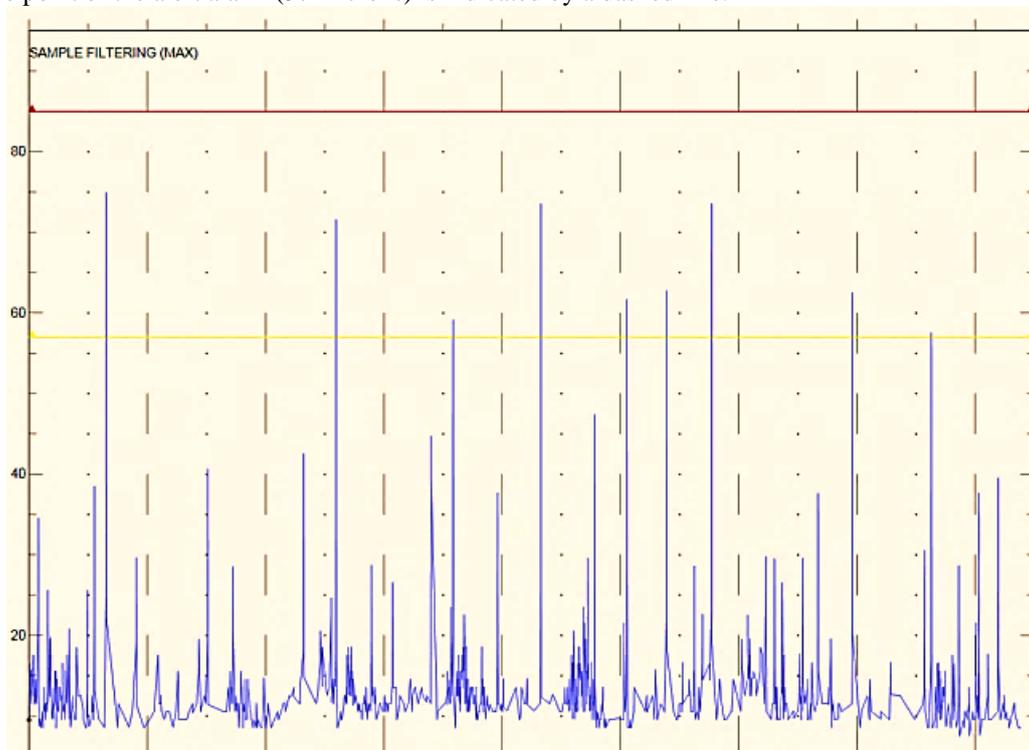
Figure 4. Vibration tendency.

From February 2002 to the end of August 2002, brief periods of high vibration were observed, with peak levels reaching 40 microns. On August 30 and 31, and again on September 2, 2002, the observed peaks rose in large numbers, reaching 75 microns, which was almost the maximum level of danger alarm, of 85 microns (Figure 4). A review of the vibration data revealed that 90% of the observed high vibration could be attributed to a 1X response (synchronous).

This Figure 4 shows occasional peaks of high vibration that occurred over a two-week period. The reference point of the alert alarm (57 microns) is indicated by a dashed line.

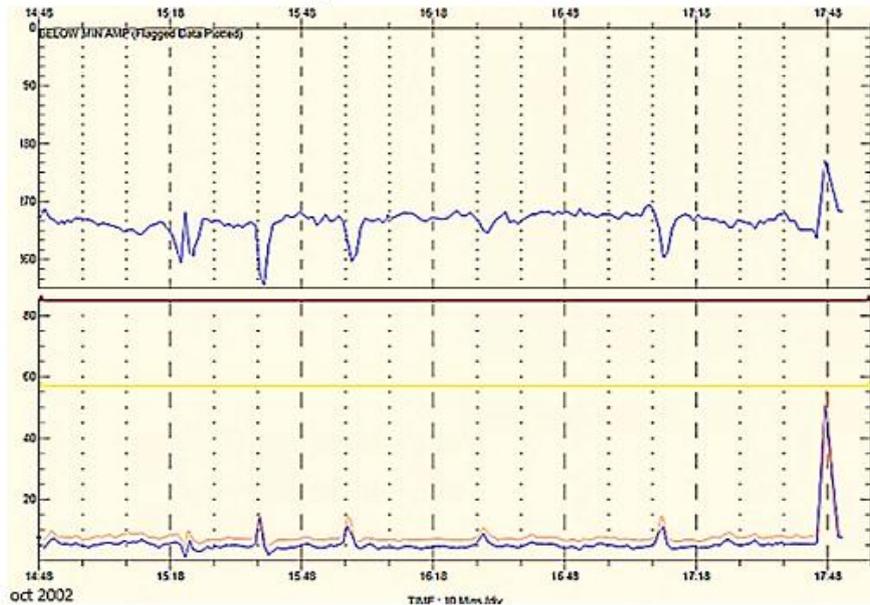
Figure 5. High vibration intervals.

A closer evaluation showed that brief recurrent periods of high vibration started from normal levels of 10 to 15 microns, quickly rose to such a high peak value of 50 to 75 microns, and then quickly fell back to normal levels. Each event lasted from about 5 to 15 minutes (Figure 5). The peaks appeared at intervals ranging from 8 hours to 3 days. During some of the high vibration events, operators who were near the turbine reported that they could feel and hear significant increases in vibration from the machine.

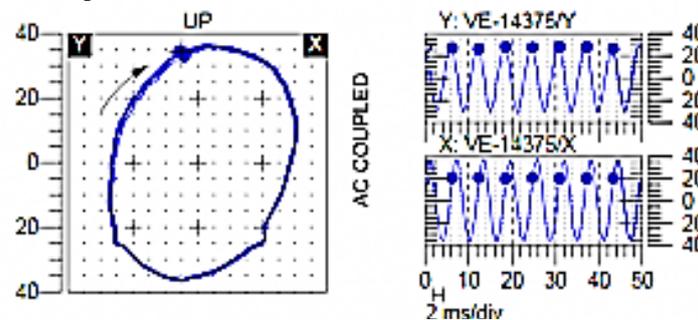
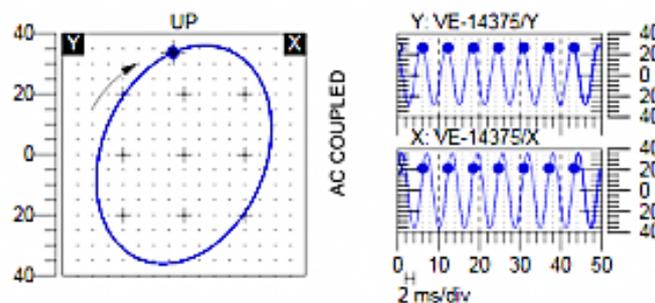
Figure 6 and Figure 7 show the phase and amplitude of the vibration (both filtered and unfiltered-1X). The shape of the orbit shows the behaviour of a typical short period of high vibration. In this example, the vibration amplitude was increased from normal levels (8 microns) to a maximum value of 74 microns in about 4 minutes. The orbit in Figure 6 shows the global amplitude of broadband, while the orbit in Figure 7 indicates its already filtered shape at 1X response.

Figure 6. Unfiltered 1X response.

Figure 7. Filtered 1X response

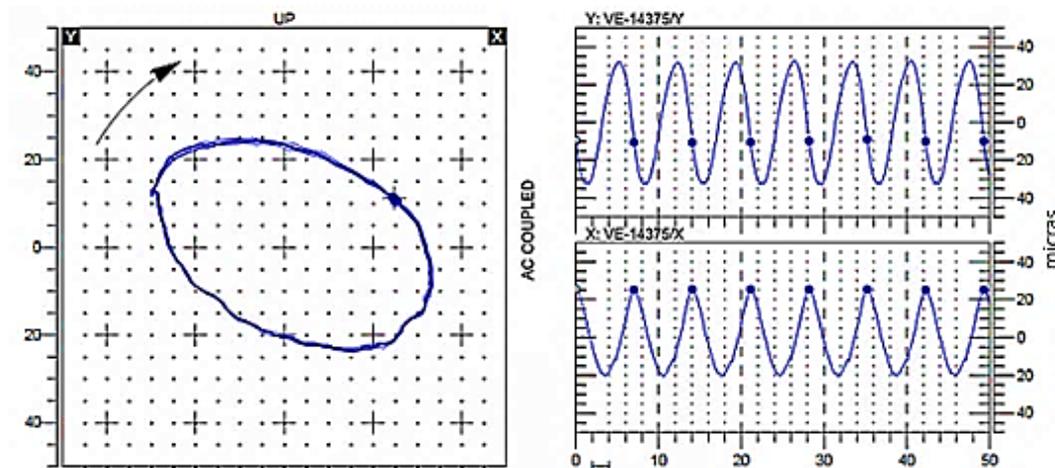
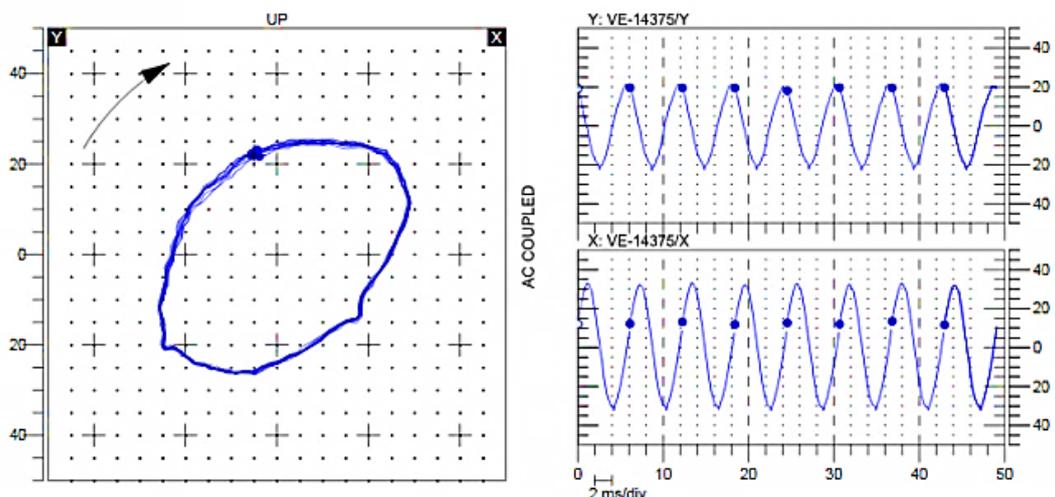
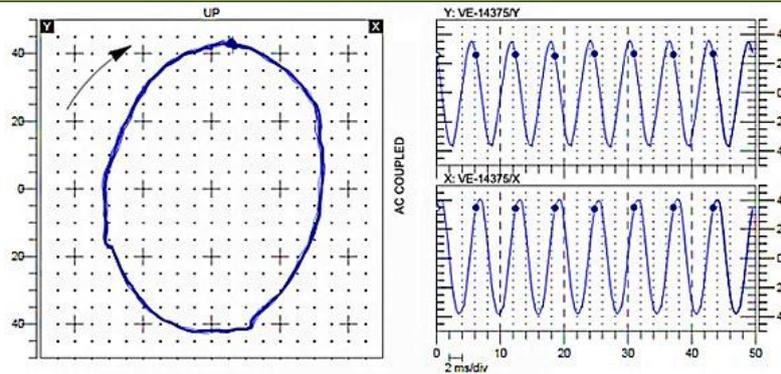
The shape of the orbits indicated the presence of an oscillation and change of situation of the phase reference mark, as indicated in Figure 9 and Figure 10. These orbits, during intermittent vibration peaks, therefore show unstable phase angles.

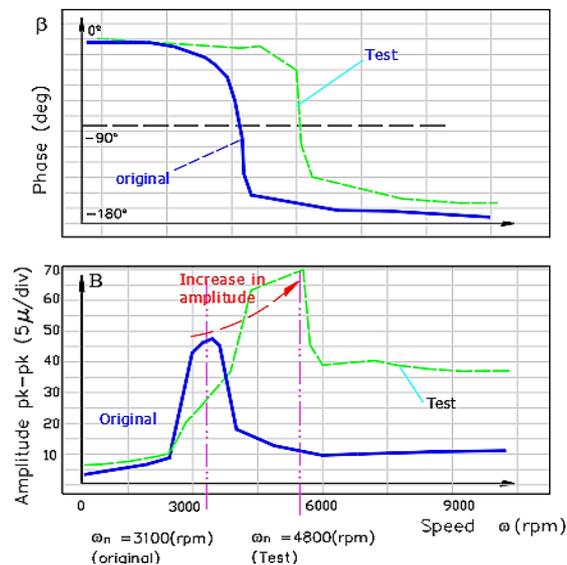
Figure 11. Bode diagram of the rotor's 1X response.

Responses such as those in Figure 11 and Figure 12 were obtained. In Figure 11, it is observed that the resonance frequency has increased with respect to the original, in addition to the fact that the amplitude of that 1X response, once the resonance region is exceeded, increases and presents an almost constant amplitude and phase angle.

These symptoms, in addition to the intermittency of high vibration, can constitute a partial rubbing, with great probability.

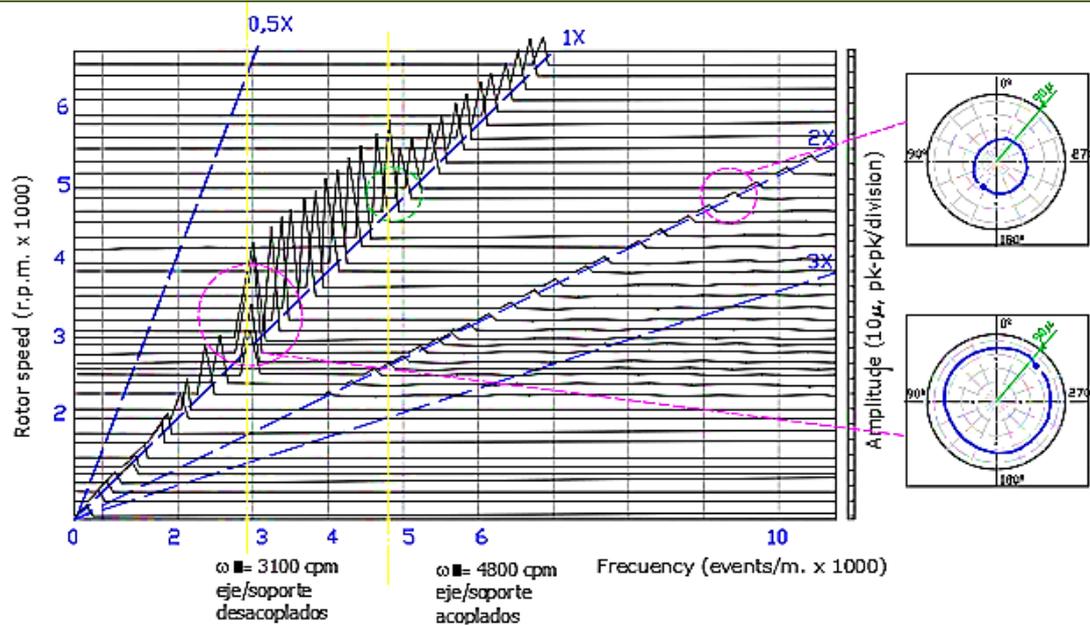
Figure 12. Cascade and orbit spectrum.

In Figure 12, it is also observed that the resonance frequency has increased with respect to the original, in addition to the fact that the amplitude of that 1X response, once the resonance region is exceeded, increases and presents an almost constant amplitude, during a certain period of time.

Orbit shapes during intermittent vibration peaks show shifting phase angles, a classic indication of friction caused by thermal arc with a transient hot spot.

In this spectrum of Figure 12, which corresponds to the start of the machine, it is observed how when the resonance speed is reached, the amplitude of the synchronous response 1X increases, that is, the movement and displacement of the shaft becomes greater. This situation could be related to the shaft initiating a friction with the mechanical support or seal of seal, and not a bearing, since the defects in bearings provide vibration signals at very high frequencies, which did not occur in this case.

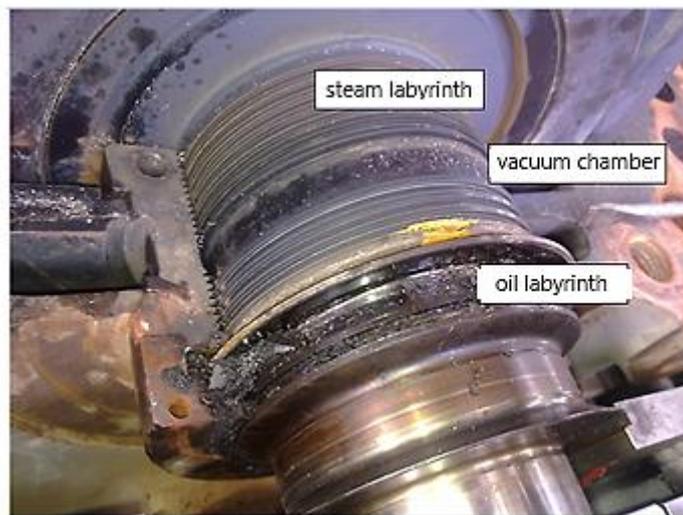
- Carbonized lubricating oil, which had accumulated in the vacuum chamber of the seal, and which had come into contact with the turbine rotor (Figure 13). Confirms partial rubbing.
- Unilateral wear of the oil labyrinth rings was discovered (Figure 14). It can mean a misalignment of the shaft.
- No significant damage had occurred to the rotor shaft, steam mazes or bearings.

Figure 13. Charred oil, visible in the vacuum chamber, immediately after the closing of the labyrinth.

- A high misalignment between the turbine supports, up to 1 mm. Misalignment caused uneven wear on one side of the oil maze rings or seal, causing a partial friction of the shaft on the seal.
- Excess oil seeped into the space between the oil rings and the vacuum chamber.
- Oil vapor mixed with high-temperature steam was introduced into the vacuum chamber, immediately after the labyrinth closure.
- The hot oil formed a hard charred "residue", which caused a partial friction in that sector of the seal.

Within a few minutes, the coal deposits were polished until the problem disappeared, but the oil leak would form more coke and the cycle could be repeated over time.

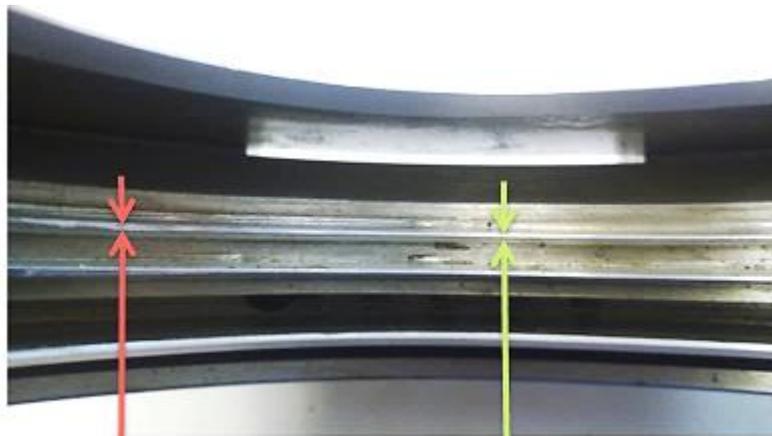
Figure 14. This photo shows uneven (one-sided) wear of oil labyrinth rings

In order to avoid, then, the repetition of a similar incident in the future, the misalignment of the turbine was investigated, in response to that uneven wear of the labyrinth closure that was reflected in Figure 14.

The turbine had been properly aligned at the ship's previous scheduled shutdown, and was installed in its already closed and assembled foundation. No apparent causes of the subsequent misalignment were found, but the turbine manufacturer reported that, despite the stiffness of the foundation, mismatches similar to the one analysed can sometimes occur during the first months of the operation of a new or regenerated turbine. To avoid similar incidents in the future, it is considered necessary to carry out the hot alignment of the equipment, after 3 to 6 months of operation.
