# Bridge Improvement and Foundation Protection Method for Wu-Xi Bridge

**Abstract:** The Wu-Xi Bridge, located on Provincial Highway No. 63 and spanning the Wu-Xi between Taichung City and Nantou County, has experienced significant structural challenges due to severe scouring and floodplain migration following typhoon-induced flooding after 2002. In particular, the caisson foundations of Piers P42 to P47 have become critically exposed, with depths reaching up to 8 meters—posing substantial risks to the bridge’s structural integrity. To address these issues, the Directorate General of Highways initiated a comprehensive improvement project that includes geological investigation, structural assessment, and pier reconstruction. The project involves replacing the vulnerable caisson foundations with full-casing pile foundations to enhance flood resilience and seismic performance. Empirical scour analysis, hydrological assessments, and structural evaluations under both normal and seismic conditions confirm that the new design significantly improves safety margins, with all key safety factors exceeding required thresholds. This project ensures the long-term durability and safety of the Wu

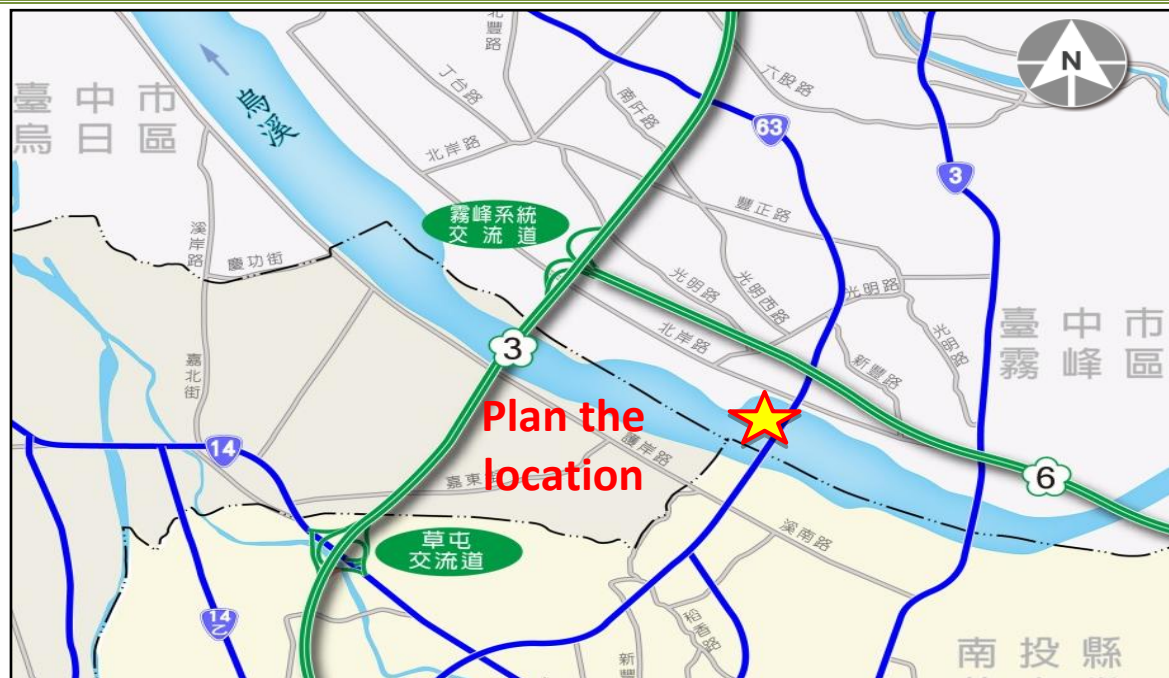
Figure 1-2-1 Schematic diagram of the scope of the project

The project bridge is located along Provincial Highway No. 63, between KM 13K+806M and 14K+879M, spanning the Wu-Xi and connecting Wufeng District, Taichung City and Caotun Township, Nantou County. This bridge not only serves as a critical inter-county crossing over the Wu-Xi, but also provides a direct connection from Provincial Highway No. 63 to National Freeway No. 3. The project location is shown in Figure 1-2-1.
